Manhole Inspection Summary

Manhole # S51K__021MH

Insp Date: **4/1/08 11:00 AM**

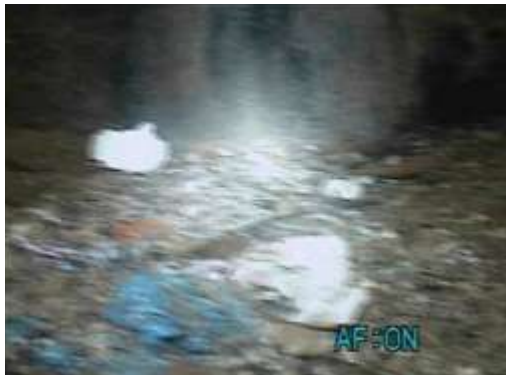
Defect 5

Condition: ☐ Sound ☐ Cracked ☐ Root Intrusion ☐ Deteriorated ☐ Leaks ☒ **Debris**

channel debris

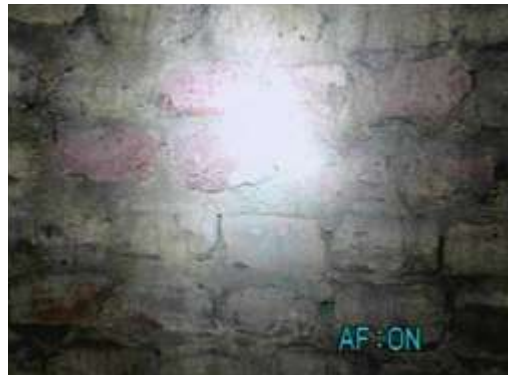
Defect 4

Condition: ☐ Sound ☒ **Cracked** ☐ Root Intrusion ☐ Loose Brick ☐ Deteriorated

crack in barrel

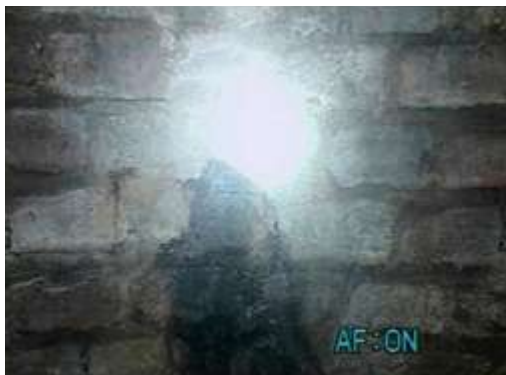
Defect 3

Infiltration: ☐ None ☐ Joint ☒ **Cracks** ☐ Mortar ☐ Roots ☐ Wall

infiltration in barrel

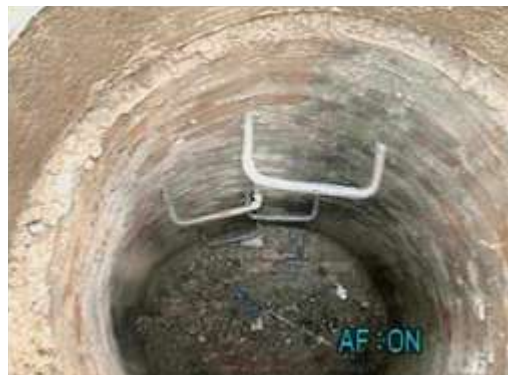
Defect 2

Steps Count: **4** Missing: **0** ☒ **Corroded**

steps

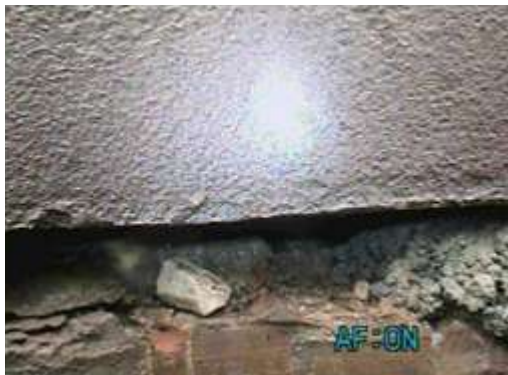
Defect 1

Condition: ☐ Sound ☐ Cracked ☐ Root Intrusion ☐ Loose Brick ☒ **Deteriorated**

Chimney deteriorated
Frame adjustment
